# USAAVLABS TECHNICAL REPORT 67-21

## XV-11A DESCRIPTION AND PRELIMINARY FLIGHT TEST

This report is a presentation of a research project currently being undertaken at Mississippi State University, in which an aerodynamic research aircraft, the XV-11A, is being used to explore the problem areas associated with STOL fixed-wing aircraft.

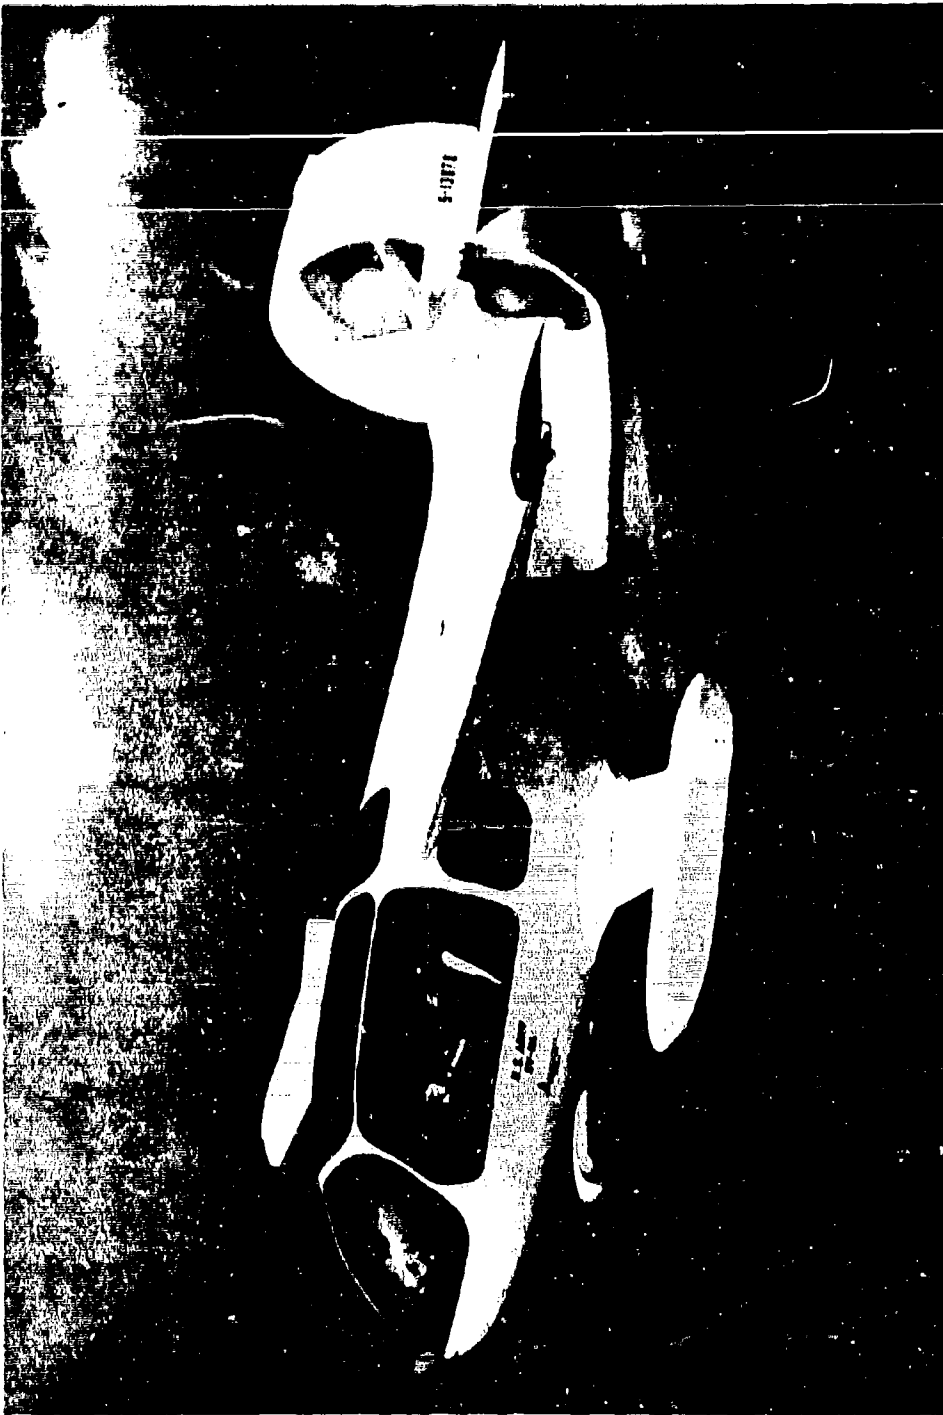
Figure 1. XV-11A Research Aircraft.

The Aerophysics Department of Mississippi State University has been performing research in high lift and thrust augmentation for a number of years. The Department has designed and assembled a vehicle which uses distributed suction boundary layer control to attain high-lift coefficients and a shrouded propeller to increase the static thrust of a propeller (see Figure 1). The aircraft, designated the XV-11A by the United States Army, was constructed of fiber glass materials to facilitate the construction of the complex shapes required to satisfy the design objectives of the XV-11A. The primary purpose of this aircraft is to investigate the areas of high lift, low drag, and thrust augmentation.

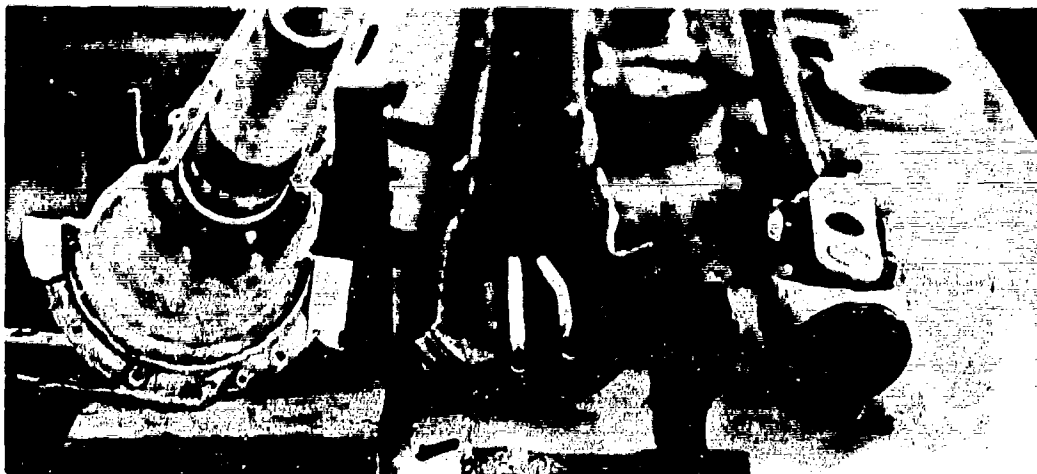
a. Propeller Shaft and Fiber Glass Housing.

Power is taken off at the rear power takeoff pad as it is in a helicopter installation. Transmission is via a 1-3/8-inch O.D. tubular steel shaft turning at 6000 r.p.m. to the aft gearbox which supports the propeller and reduces the speed to 2070 r.p.m. The 7-foot-long shaft is supported by a fiber glass housing containing intermediate bearings every 15 inches. A constant-speed universal joint allows the drive to bend through 11 degrees just ahead of the aft gearbox. The shaft, housing, and gearbox are removable from the aft end of the airplane. Photographs of the engine installation and the drive shaft are shown in Figures 8 and 9, respectively.

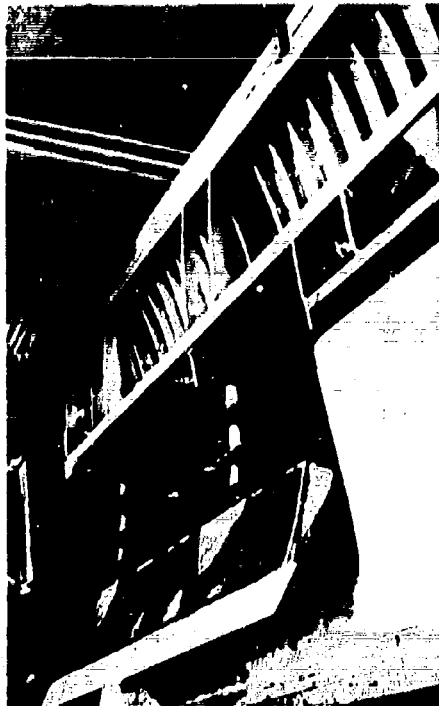
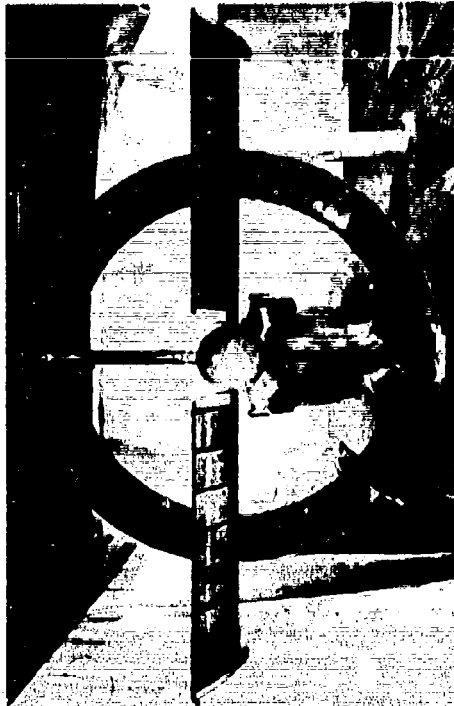
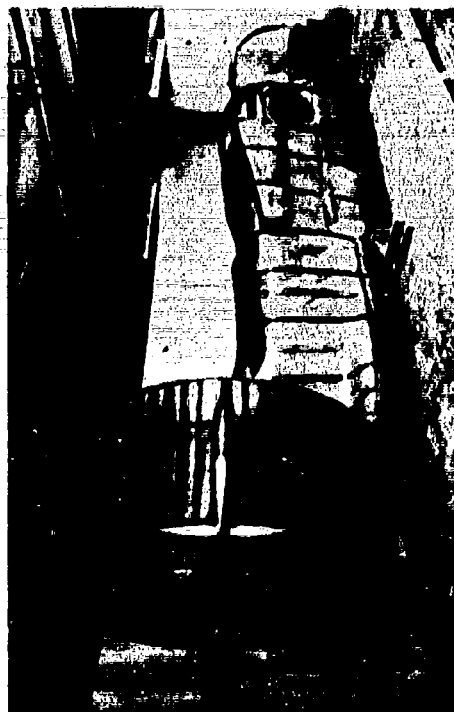
Figure 13. Views of the Aircraft Under Construction.

Generally, the structure may be described as a rib or a bulkhead-supported molded skin assembled with an epoxy bond. Views of the aircraft components under construction are shown in Figure 13.

Wing skins were laid up in large wooden molds with matching plaster male molds clamped in place with three bolts passing through inspection panel openings. Stainless steel spar caps were laminated in place with successive overlays of cloth. All spars, ribs, and camber-changing mechanism supports were bonded into the top skin as it lay inverted in the mold (see Figure 13). The camber-changing horns and drive mechanism were added at this time. Subspars were fitted into their piano-hinge counterparts which were built into the wing skins. Wings were completed by bonding on bottom skins which contained the inspection panels for the camber-changing mechanism.

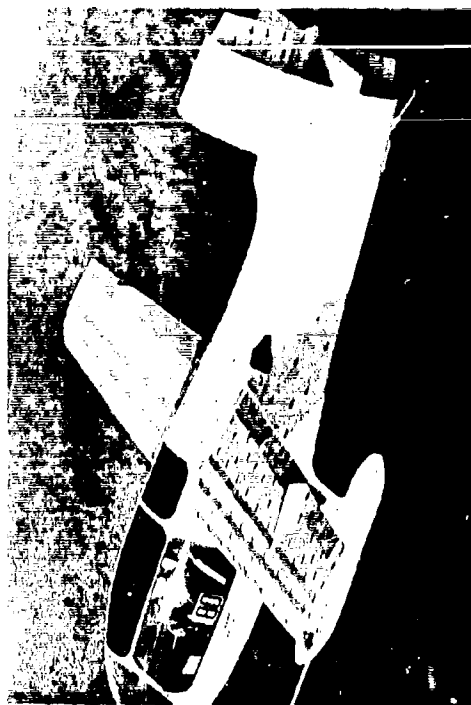
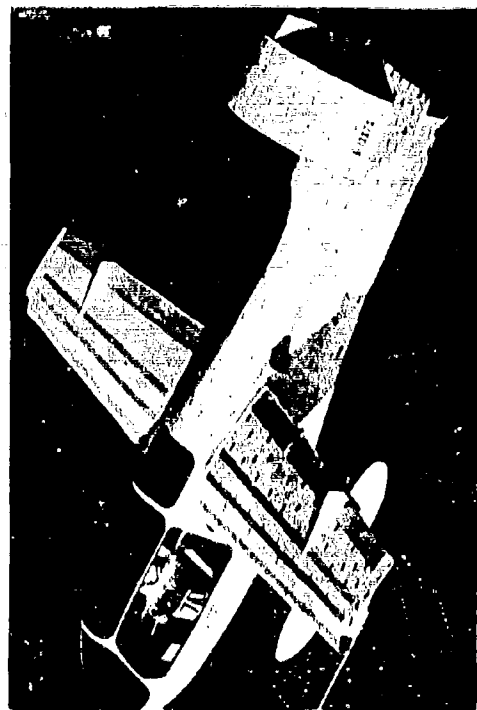
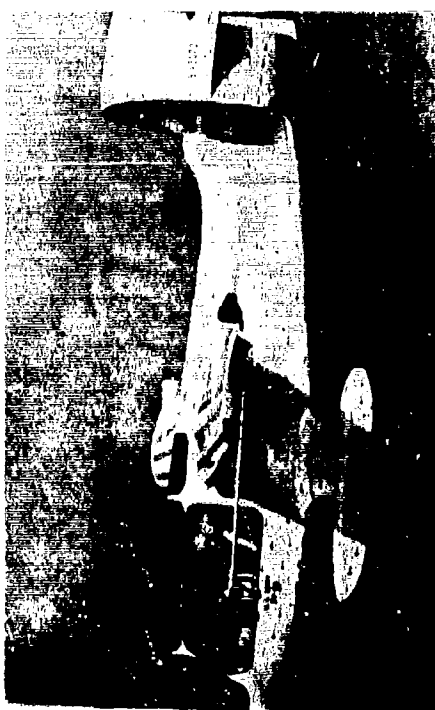
Figure 31. Aircraft Tuft Pictures, Cruise Configuration.

One advantage of fiber glass construction, especially for limited production or a one-of-a-kind vehicle, is the relative ease of fabricating complicated, compound curvatures free of any joints or other protuberances. The XV-11A is an excellent example of the possibilities of this type of construction, and the photographs in Figure 30 show the resulting disturbance free flow. The tuft pictures of the cruise configuration for a range of flight velocities are presented in Figure 31. The numbers displayed in the aircraft window represent the indicated airspeed in miles per hour. The airspeeds of 120 and 130 are represented by 20 and 30 in the photographs. There is no detectable area

of flow separation for the cruise configuration. Figure 30 presents the tuft photographs for the 30-degree camber configuration. Except for the separated flow on the wing, which is discussed in the following paragraph, there is no area of separation apparent with this configuration.
